E. OTHER BUILDINGS ON CAPITOL HILL

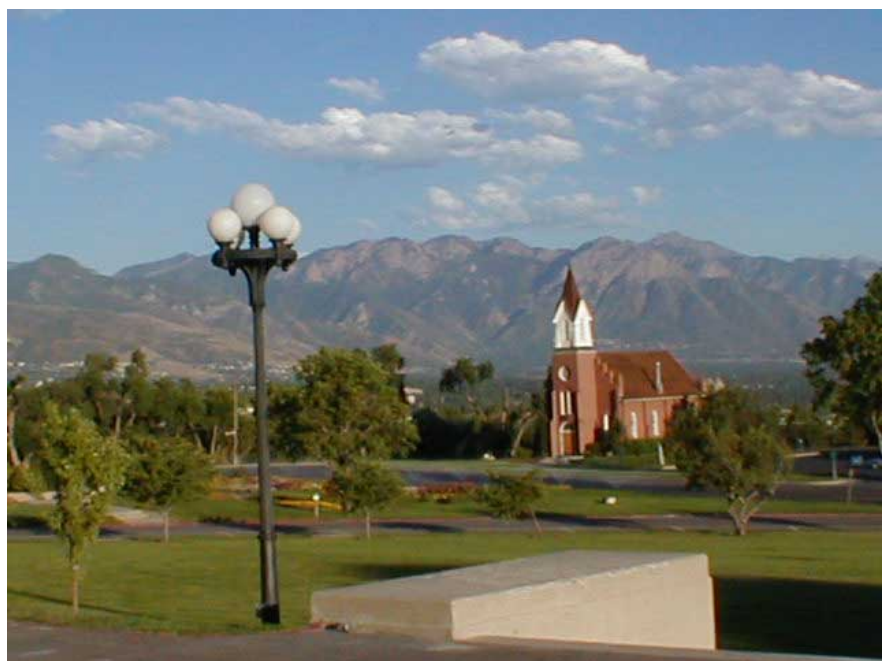
White Chapel

Its style is Gothic revival masonry and incorporates a number of the artifacts from the original building including: the steeple, cornerstone, leaded glass windows and frames, doors (front doors have varnished Kick plates re-plated in bronze), benches, pulpit and interior woodwork. Brass handrails adorn the balcony wall and stairs. These were not on the original drawings and have been added. The rails are not historic but do not warrant replacement. Handrails on the wall side of the stairs are made of straight pieces that have been poorly attached to the wall and should be replaced.

The roofing is oiled cedar shingles with a board ridge comb (redwood ridge design). The shingles are slightly curled; some are broken and should be oiled. The steeple, original to the earlier chapel, is also of wood and cedar shingles. The exterior of the building is brick masonry veneer over board insulation and 12" structural concrete masonry units. The exposed foundation wall is plastered concrete. The walls are constructed with buttressed piers in 4 bays, covered with sloped bricks. Some bricks have broken loose and need to be replaced.

The chapel has two exits -- the main entrance and an emergency door to the south. The basement level has a direct exterior emergency exit to the south. The restrooms do not meet ADA requirements. Exterior items that need attention are: painting wood windows and resetting pier cap bricks. The cedar roof may need repair or replacement in the next few years.
